Analysis Using AFT Fathom™ Reveals Root Cause for Fire Pump System Over-Pressurization

CASE STUDY

Fire Protection System
Power Industry

CB&I Inc.
Pitman, New Jersey, USA
Platinum Pipe Award Winner - Correlation to Test/Field Data

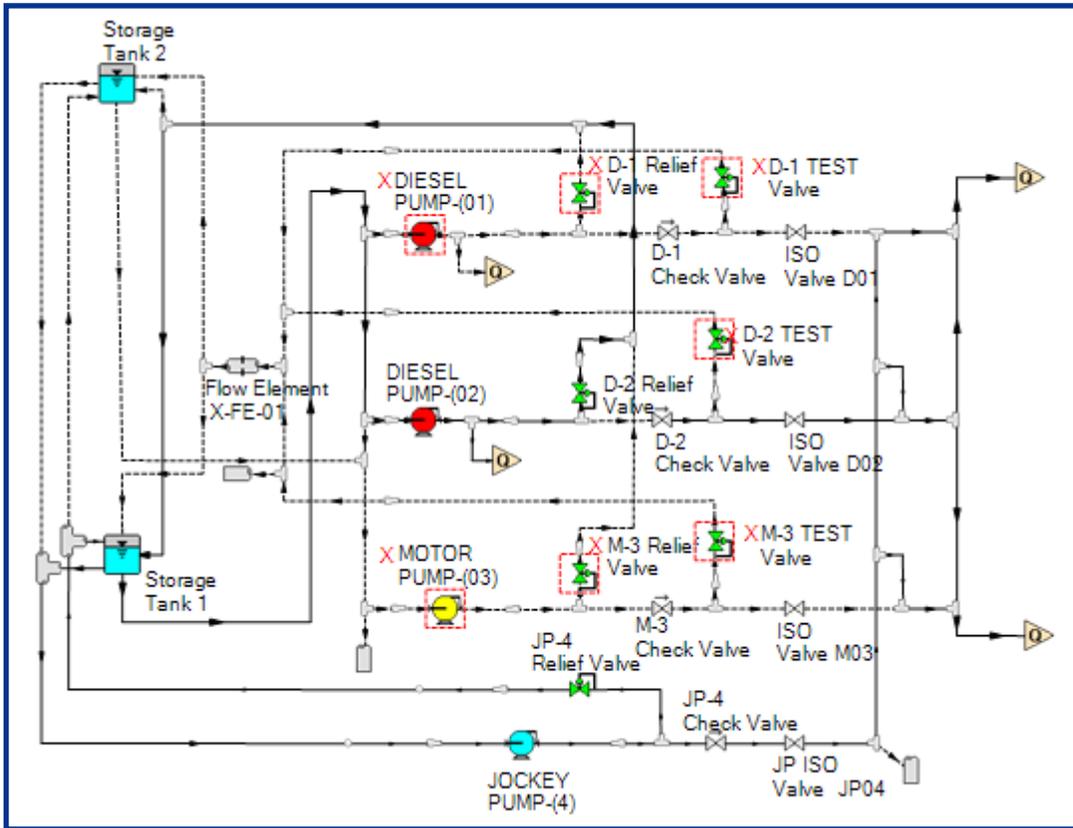
Figure 1 - Fire pump system

Piping arrangement drawings, valve loss data and pump performance test data were used to prepare an accurate physical model of the system. Multiple pump field tests were used to prove the calibration of the system over a wide range of operating points. With design and test detail provided, Williamson confirmed the model's integrity and validity (see Figure 1).

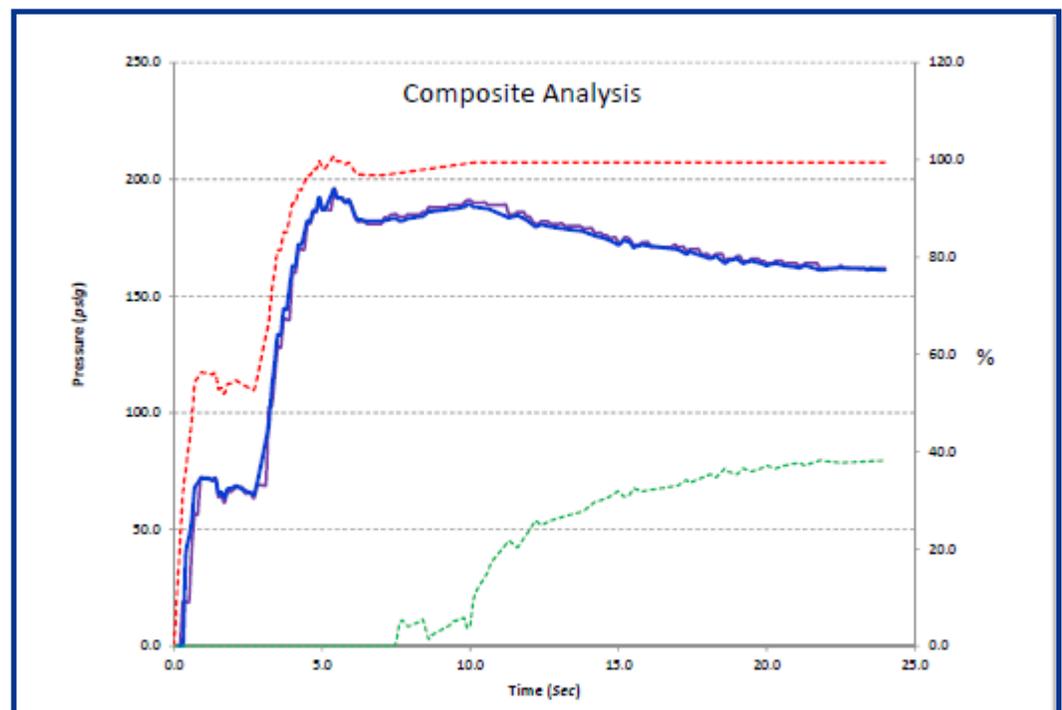
Figure 2 - Composite analysis of scenario

Williamson suggested that the pump speed contributed to the early portion of the event and the valve response was delayed until late in the event. As he tracked the pump speed prediction, he observed the lowest speed that occurred after the first peak was at 7 seconds. After the 7 second lull, the second peak occured at 10 seconds. He assumed that the pump achieved its running speed in about 10 seconds. The pump speed was set to increase from the low at 7 seconds to 100% at 10 seconds and then remain constant.

Williamson applied this pump curve to the model and allowed the valve to track the transient from the 5 second event. He observed that the valve cycled open and closed twice. This was unlikely as once the valve began to respond it would not close while the pressure was above the set-point. Therefore, the second activation of the valve opening was most likely the true initiation of the valve. The valve response was initiated at ~7 seconds as the pump began its final ascent to 100% speed. As the pump achieved stable speed, the valve responded to the pressure surge, opening and continuing to modulate to the end of the simulation. It was apparent that the valve response time was too slow.

The composite result of this scenario is shown in the graph below (see Figure 2).

Once the analysis was presented to the owner, they disclosed that a number of modifications had been performed on the relief valve which slowed the valve response time down considerably. It was estimated that the valve which was originally designed to open in ~3 seconds took as long as 10 20 seconds to respond. The remainder of the project was directed toward restoring the faster response time for the valve.

The pump speed (red) and valve positons (green) are depicted (dashed lines) in terms of the percent scale on the right of the graph. The resulting actual discharge pressure (blue) tracks similarly with the predicted pressure (purple) on the left hand pressure scale.
